SURFACE STUDIES OF DIELECTRIC MATERIALS USED IN SPARK GAPS*

G. Jackson, L. Hatfield, G. Leiker, Physics Dept.;
 M. Kristiansen, M. Hagler, A. Donaldson, R. Curry, R. Ness, Electrical Engineering Dept.;
 J. Marx, Chemistry Dept.
 Texas Tech University
 Lubbock, Texas 79409

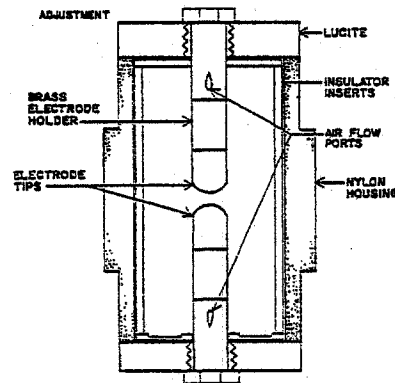
Fig. 2. Mark II Spark Gap.

The Mark II spark gap, shown schematically in Figure 2, was used to expose Lucite insulators to 50,000 shots from an unipolar discharge.² The insulators were inserted as cylinders, located 6.25 cm from the discharge region between two 2.5 cm diameter hemispherical electrodes, which were graphite, copper-graphite composite, two different tungsten-copper composites (K-33 and Elkonite), or stainless steel. The spark gap normally operates at a voltage of less than 30 kV and switches 9 kJ of energy in 25 μ s at a maximum rep-rate of 5 pulses per second, a maximum current of 25 kA and a maximum charge transfer of 0.6 Coul per shot. The chamber is continuously flushed so that one chamber volume flows through every 5 seconds with either air or N₂ gas, while the pressure is maintained at 1 atmosphere absolute.

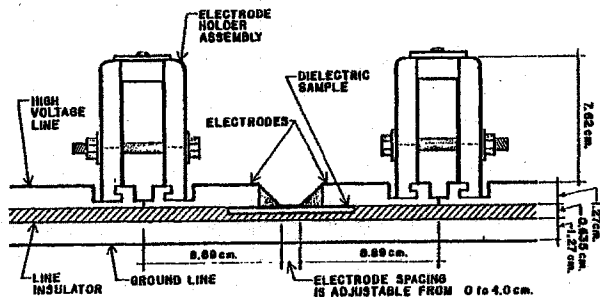
Fig. 3. Surface Discharge Switch.

A surface discharge switch, shown schematically in Figure 3, was used to expose Blue Nylon, Lucite, boron nitride, and Delrin insulators to 10,000 shots

from a "gliding" discharge across the insulator surface.³ The switch operates at 45 kV in the ambient atmosphere (lab air) and transfers 180 joules per shot at a rate of 1.2 pulses per second. It was observed that after a few shots the switch stopped multichanneling. However, when an air jet of "dirty" lab air was blown across the surface of the insulator the sample continued to multichannel until the air jet was turned off. This phenomenon may be due to an accumulation of surface charge which deters multichanneling and the air jet somehow manages to alter this distribution of surface charge so that multichanneling can still occur.⁴

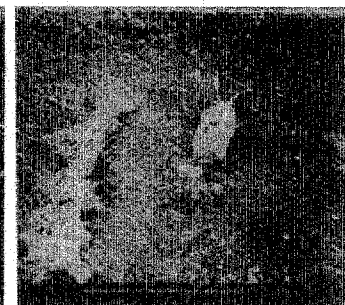
Fig. 7. Magnified view of a portion of Fig. 6. Bar length is 100 microns.

micrographs of the surface showing a thin, discontinuous layer and some 10 to 100 micron size particles. X-ray dot maps on several particles show mainly copper on a tungsten background. This may mean that the copper and tungsten are deposited on the insulator at similar rates, but the tungsten, which has a rapid rate of reduction compared to copper, is oxidized by the oxygen in the spark gap in the form of water.

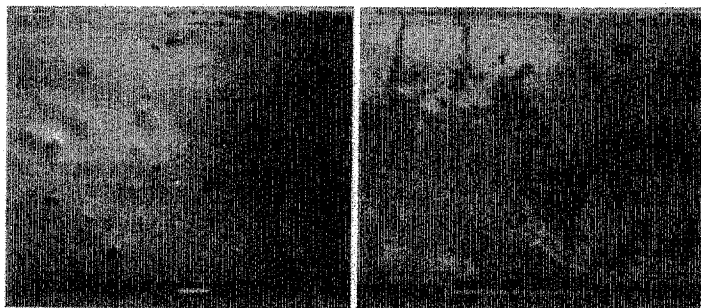
Fig. 9. SEM micrograph of Lucite used in Mark II with graphite electrodes and air for 50,000 shots. Bar length is 100 microns.

Fig. 10. SEM micrograph of Lucite used in Mark II with copper-graphite electrodes and air. Bar length is 1000 microns.

In the Mark II gap the Lucite insulators are cylinders concentric with the electrodes, with the insulator wall located 6.25 cm from the discharge. When graphite was used as the electrode material with air flowing through the gap, the Lucite showed no visible (naked eye) signs of electrode material coating but there were signs of crazing on the insulator in the region nearest the discharge. Surface analysis using ESCA showed no apparent change from a virgin sample. The SEM micrographs reveal a low density of microparticles on, and embedded in, the surface. A typical area, 1000 microns by 1000 microns, contained 39 particles, four of which measured about 10 microns in diameter. This is consistent with the ESCA data if the particles are assumed to be graphite. Since ESCA analyzes a large area (2 to 4 mm diameter) the low density of graphite particles would not produce a significant increase in the carbon percentage detected (71% for virgin Lucite). Figure 9 shows a typical SEM micrograph. Note that the large particles appear to be stuck on the surface while most of the smaller ones are embedded in the surface as if the Lucite melted on impact.

Figure 10 is an SEM micrograph of Lucite used with air and copper-graphite. This micrograph shows a granulated deposit on the surface. ESCA on this surface showed carbon present, but no copper. Either there is no copper on the surface (which is doubtful) or it is masked by a hydrocarbon layer.
