Surface studies of dielectric materials used in spark gaps

Citation: [Journal of Applied Physics](#) **55**, 262 (1984); doi: 10.1063/1.332857

Dielectric materials commonly used as insulators in spark gaps (lexan, nylon, lucite, macor, boron nitride, delrin, and G-10) have been exposed to the byproducts of arcs in three different spark gap experiments. The first was a 60-kV, 0.05-C/shot spark gap using copper-tungsten or graphite electrodes at various pressures of N₂ and SF₆ gas. The second was a 5–30-kV, 4–25-kA, 0.1–0.6-C/shot, unipolar, pulsed spark gap using graphite, copper-graphite, copper-tungsten, brass, and stainless steel electrodes in N₂ gas or air. The third was a 45-kV, 0.009-C/shot surface discharge switch. Surface analysis of these insulators indicates that most become coated with a thick layer of electrode material depending upon the type of gas, electrode, and insulator material used, and the conditions of the arc. However, lucite insulators inserted in the second spark gap using graphite electrodes and air showed no indications of deposited electrode material on the surface but did show small particles of graphite imbedded in the surface. The self-breakdown volt

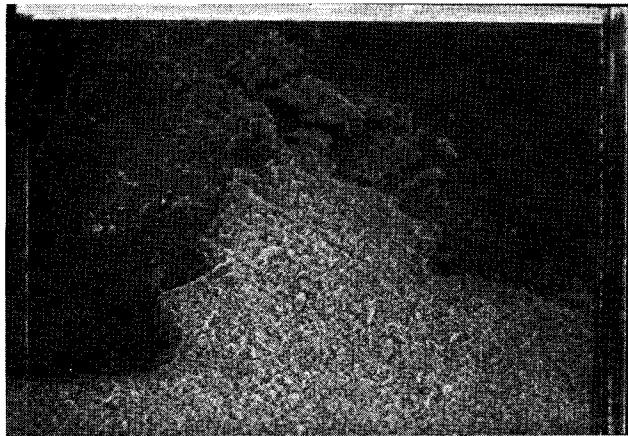
FIG. 5. SEM micrograph of a lexan insulator, which was inserted into Mark I with graphite electrodes in 2 atm of SF₆ for 5000 shots. The powdery substance on the surface is AlF₃.

Another lexan insulator was inserted into this gap with 2 atm of SF_6 and graphite electrodes. The ESCA scans of this sample showed some surprising results. The amounts of carbon and oxygen seen on this insulator are extremely small compared to the virgin sample, and there is a large amount of aluminum and fluorine seen on the surface. In addition, the surface no longer accumulates a negative surface charge as did the virgin sample but instead exhibits positive charging. The expanded scale spectrum of the Al_{2p} peak shows a shift in the binding energy of this line, which corresponds exactly to AlF_3 , and the stoichiometry of the aluminum to fluorine in the spectrum is almost exactly 3:1. Figure 5 is an SEM micrograph of this sample showing a heavy coating of powdery material on the surface. An x-ray dot map of the surface showed that this powder contains aluminum, consistent with the ESCA indication of aluminum fluoride. The fact that the surface was covered with this material explains why the measured concentration of carbon and oxygen is so small on the surface and why the surface of this particular sample exhibits positive surface charging, whereas the two previous samples show the opposite effect. The presence of the aluminum on the surface of this sample was the result of misfires

(arcs) to the aluminum walls of the chamber or arcing between the electrode and the aluminum electrode holder which liberated metallic aluminum. The metallic aluminum then reacted with the fluorine in the gas to form AlF₃ which subsequently deposits inside the spark gap. As a result of these measurements, the arcing between the electrode and the aluminum electrode holder was discovered and eliminated.

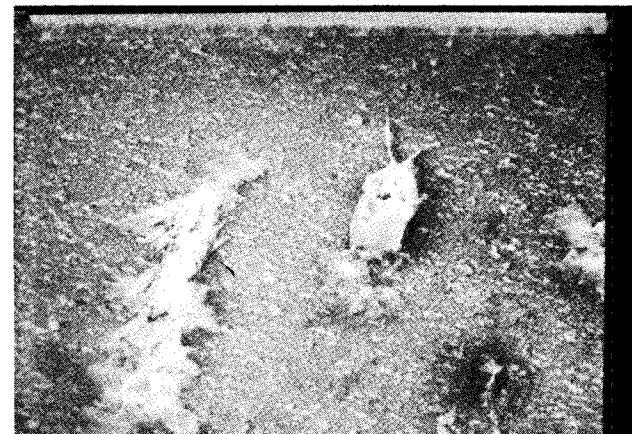
FIG. 7. SEM micrograph which shows a magnified area of the lexan insulator shown in Fig. 6.

of oxide; however, the copper spectrum shows pure metallic copper on the surface. Figures 6 and 7 are micrographs of the surface showing that it is covered with a thin, discontinuous layer of a metallic-looking substance. X-ray dot maps on several large conglomerations apparently formed from molten material indicate that they are composed mainly of copper with a tungsten background. It has been suggested that this means that the copper and tungsten from the electrodes are deposited on the insulator with similar deposition rates.⁹ The tungsten, which has a rapid rate of reduction compared to copper, is oxidized on the way to the insulator (by the oxygen in the spark gap in the form of water). Most polymers will absorb anywhere from 3% to 8% by volume of water. This could provide a source of water in the system to account for the presence of the oxygen necessary to oxidize the tungsten present on the insulator. This process yields a deposited layer of copper covered with tungsten oxide on the insulator, so that the copper in this layer never has an opportunity to oxidize even after the insulator is removed from the spark gap.

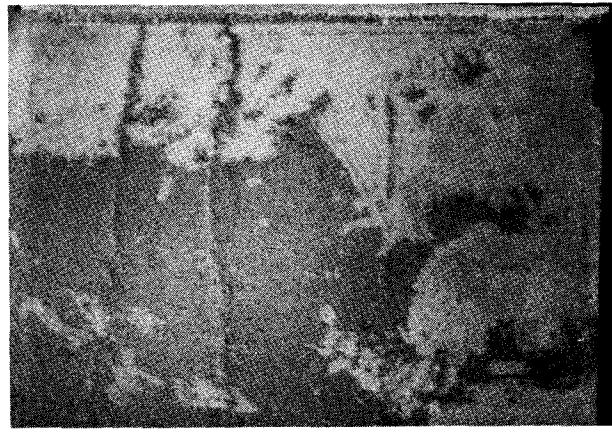
FIG. 10. SEM micrograph of a lucite insulator, which was inserted into Mark II with copper-graphite electrodes in flowing air for 5000 shots.

Figure 10 is an SEM micrograph of a lucite insulator which was inserted into this spark gap with flowing air and copper-graphite electrodes. This micrograph shows that a granulated deposit has formed on the surface of the insulator. The ESCA data from this surface showed carbon present, but no copper. Either there is no copper on the surface (which is doubtful) or the surface is masked by a hydrocarbon layer.
